31. SILO SHED

NON CONTRIBUTING
1966

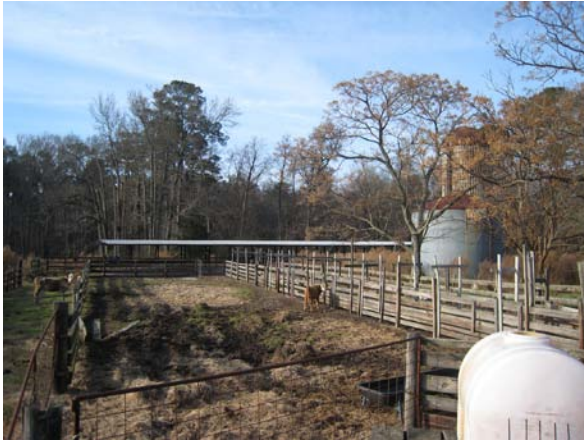
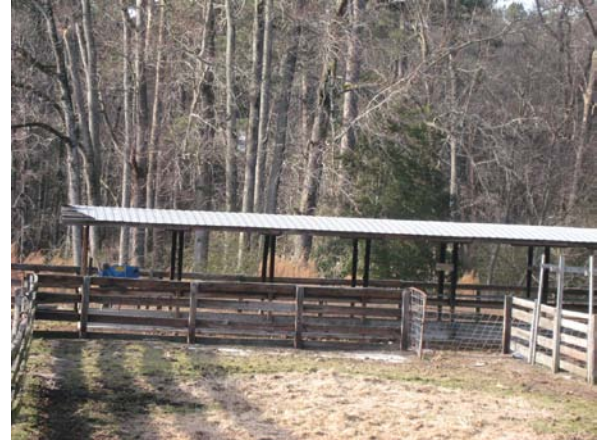
Condition: poor

Notes: rusted, some pieces torn or falling off

Notes: some joists falling off on feed roof

FCAP Recommendation: repair or replace floor, trim, and wood framing; reattach and seal metal siding and roofing

1. Same as FCAP: \$3,500
2. For assembly spaces leave open air, no AC, no plumbing. Add only fans and electric: \$8,000

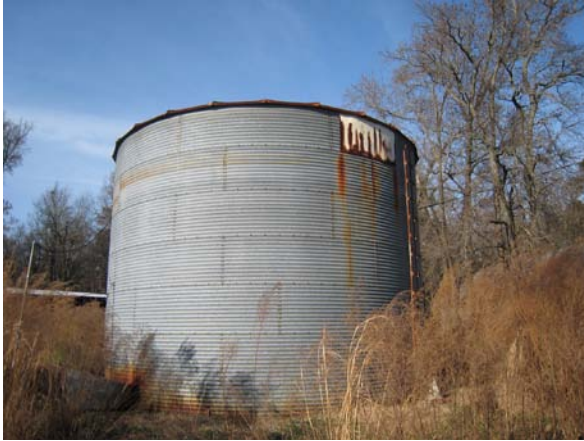
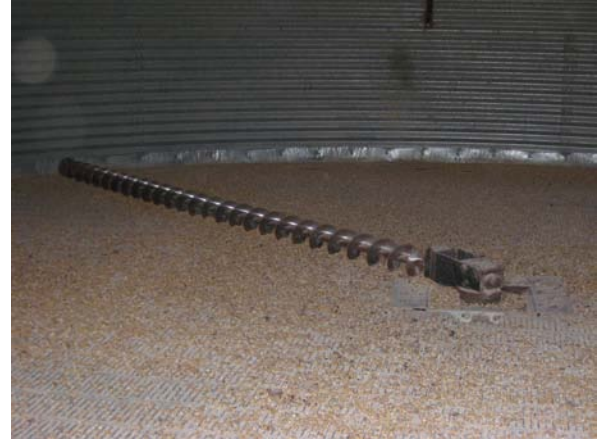
32. GRAIN BIN

Condition: poor

Notes: rusting

Note: FCAP report says "grain bin is in good condition", then recommends replacing the walls and roof which would mean rebuilding the entire grain bin

FCAP Recommendation: replace metal walls and roof

1. Repair exterior, trim foliage, create secured viewing: \$6,000

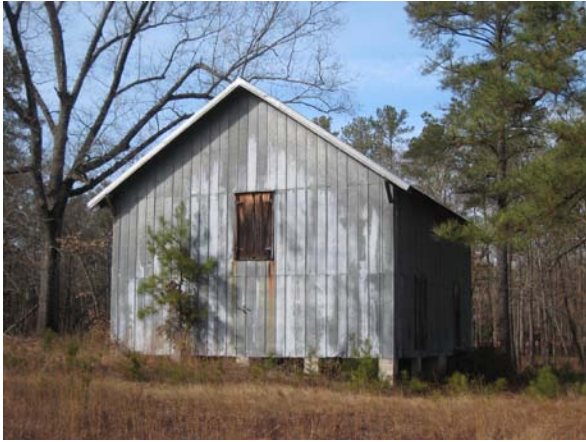
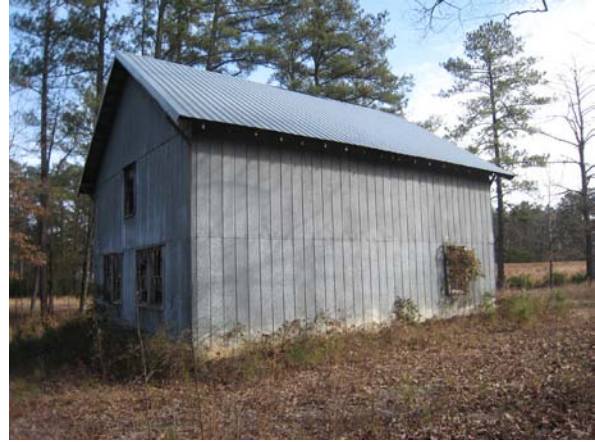
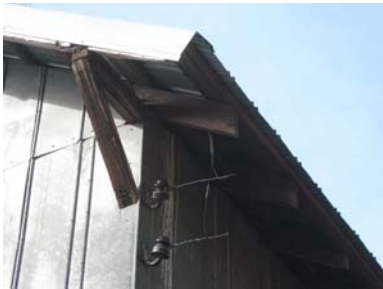
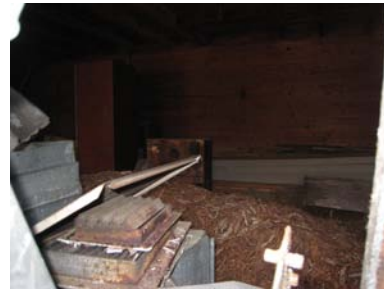
47. PACK HOUSE

Foundation System: concrete block piers, concrete apron with crawl space. Wood floor over joists.
Condition: fair
Notes: holes in apron on north side

Structural System: 2x8 wood frame
Condition: fair
Notes: 2 stories (bowed 2nd story floor)

FCAP Recommendation: replace roof, wood door, and windows; repair metal siding

1. Clean debris out of inside, cut back over grown trees in drip line, repair exterior only, and secure: \$30,000
2. Demolish: \$5,000

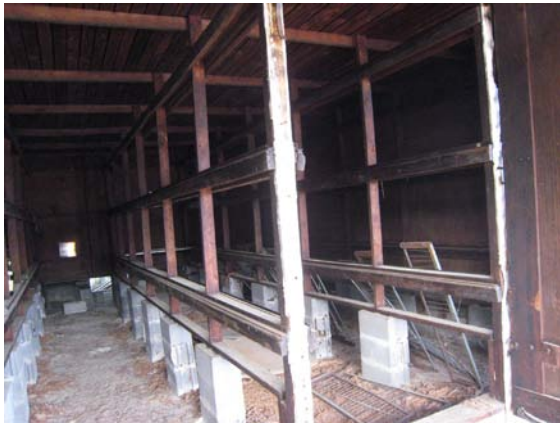
1

1. inside of barn
2. back of barn with broken door
3. siding and overgrowth

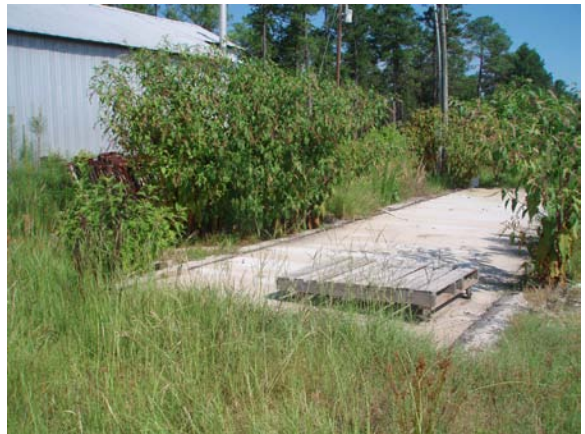
4

4. adjacent concrete pad to East

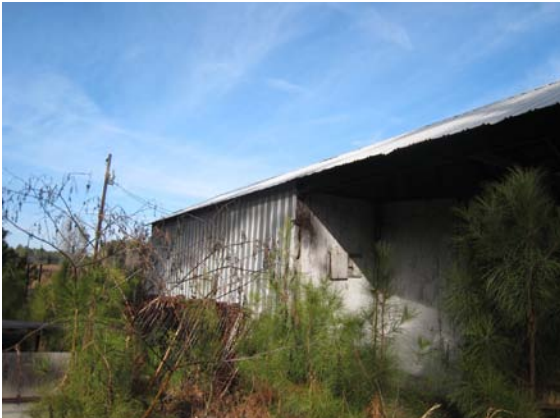
3

Cladding System: vertical metal siding
Condition: fair
Notes: overgrowth of plants may be hiding damage and causing wear on siding

ECA Recommendation & Opinion of Project Cost:
1. Remove overgrowth, repair exterior, repair doors: \$4,000
2. Unstaffed, unconditioned visitor contact station (orientation and educational signage, benches, gravel path only): \$5,000. 3. Add slab on grade: \$3,000

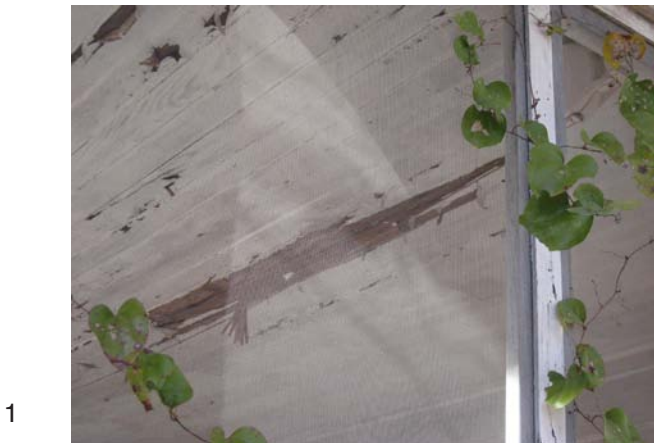
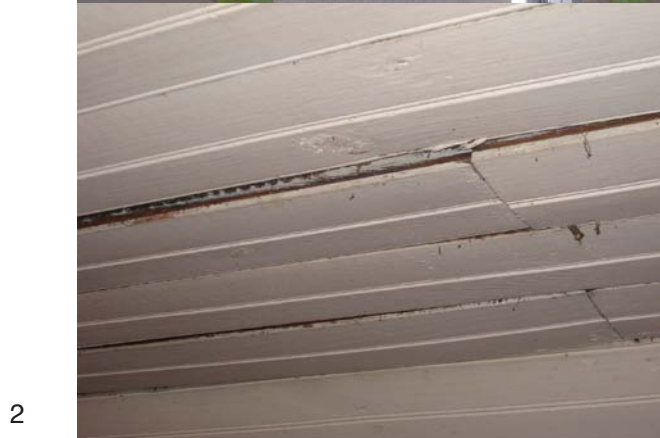
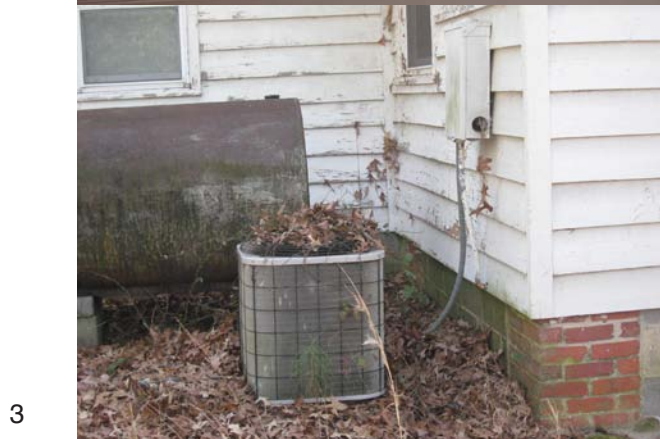
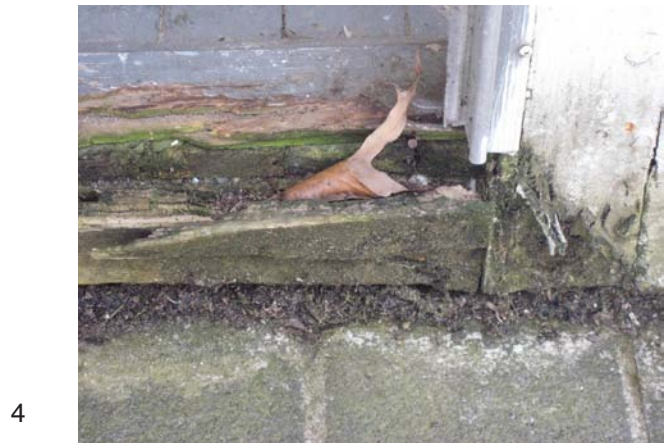
1. screen porch ceiling and growth
2. porch ceiling
3. AC unit

4. doorway rot

FCAP Recommendation: replace deteriorated porch flooring, exterior siding and trim; repaint siding and trim; scrape, sand, clean, seal, and repaint metal roof; install insulation at the floor system crawl space

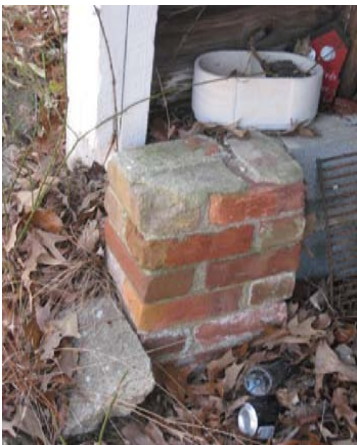
Notes: South wall has come off foundation

1. wall completely off foundation
2. wall coming off foundation

1. Demolition: \$1,000
2. Reseat on foundation, repair exterior, make secure: \$3,000

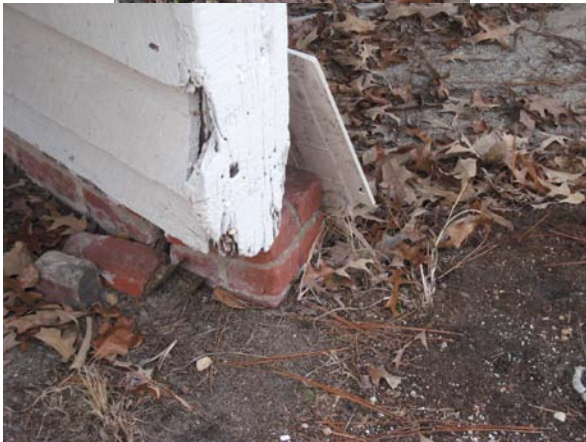
Notes: cracking, some bricks dislodged causing structural damage to wood structure

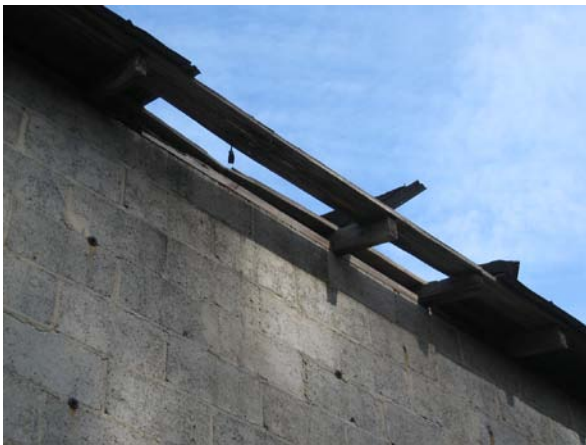
1

1. exterior roof, missing boards
2. interior space, low entrance, drying boards
3. roof structure, rot and holes

1. Repair roof, clear brush away, add pathway: \$6,000
2. Add restrooms and showers: \$40,000-\$90,000 (depending on access to water, sewer, septic) (Alternative means are possible such as composting toilets and solar hot water and could reduce costs as well as add to the environmental educational aspects of the campground)

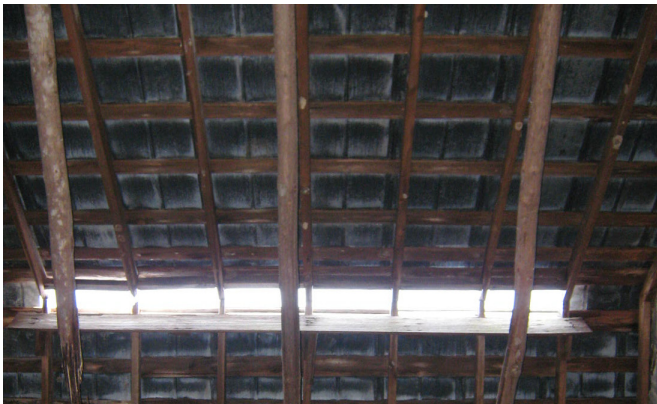
1

1. roof detail
2. interior space and drying boards

FCAP Recommendation: replace roof; install doors in openings; restore tier poles and tobacco barn to period architecture

1. Repair roof, clear brush away, add pathway: \$5,000
 2. Add restrooms and showers: \$40,000-\$90,000 (depending on access to water, sewer and septic)
- Alternative means are possible such as solar hot water which may add to the environmental educational aspects of the campground but will not reduce the renovation costs.
